TECHNICAL NOTE 3275

INVESTIGATION OF THE EFFECT OF IMPACT DAMAGE ON FATIGUE
STRENGTH OF JET-ENGINE COMPRESSOR ROTOR BLADES

By Albert Kaufman and André J. Meyer, Jr.

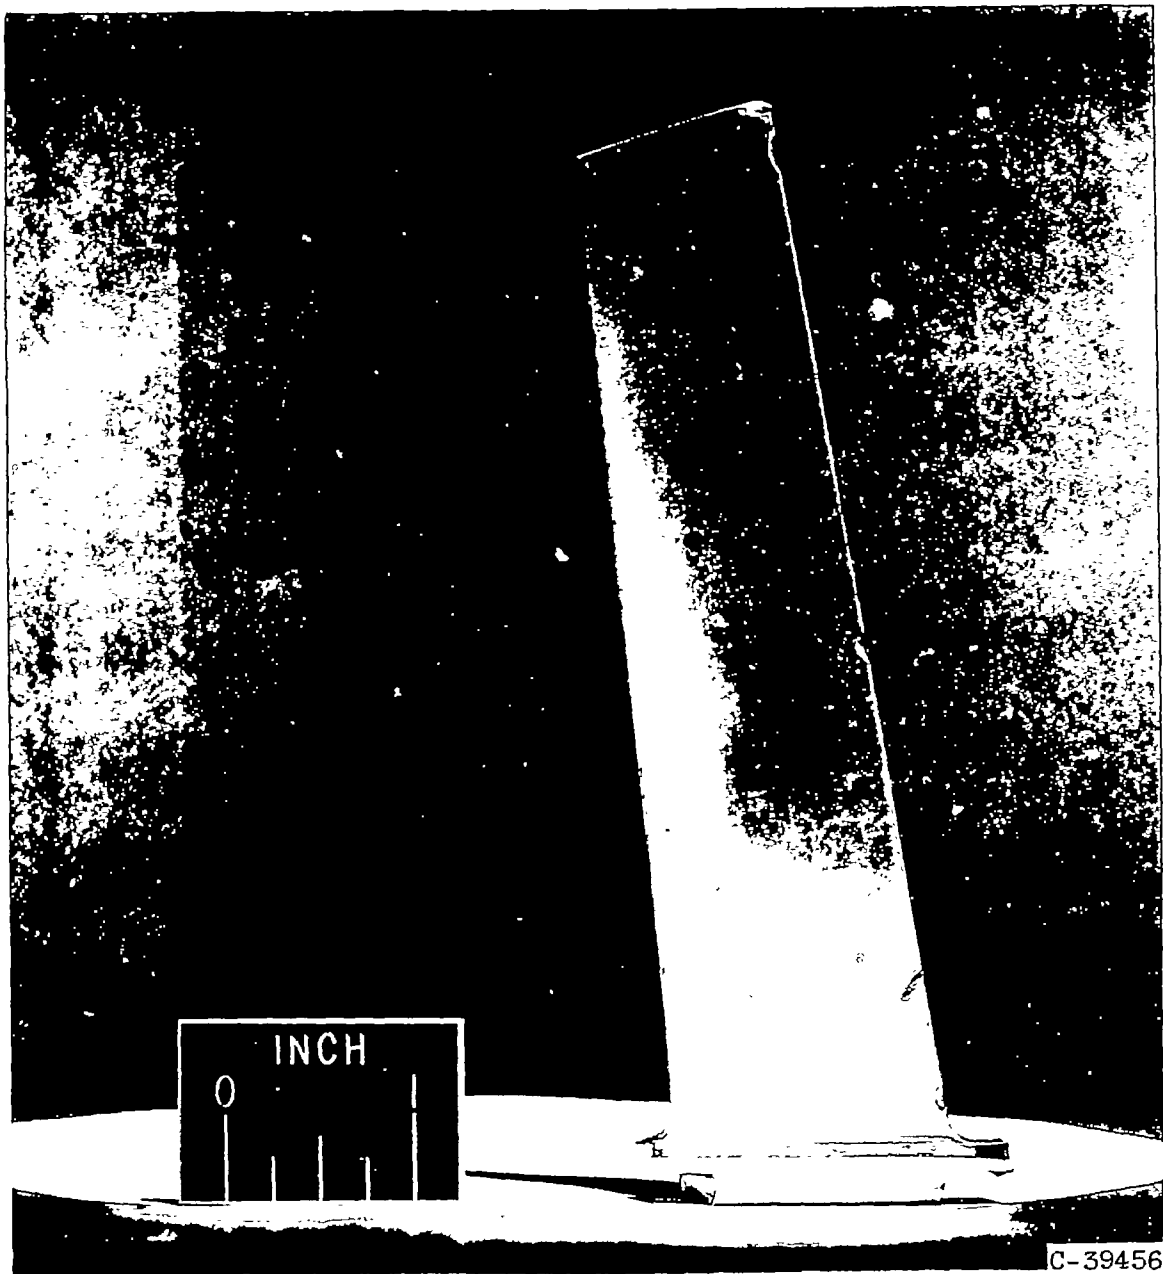
Forty first-stage compressor blades which had been damaged to some extent were removed from the rotor and used for this investigation. One of the blades is shown in figure 1; some were more and others were less severely damaged. The damage defects were distributed over the pressure surfaces and the leading and trailing edges of the airfoils. None of the blades suffered damage on the suction surface. In this report, breaks or tears in the surface of the metal are called nicks, whereas surface deformations without breaks are termed dents (fig. 2).

Figure 1. - Typical damaged blade.

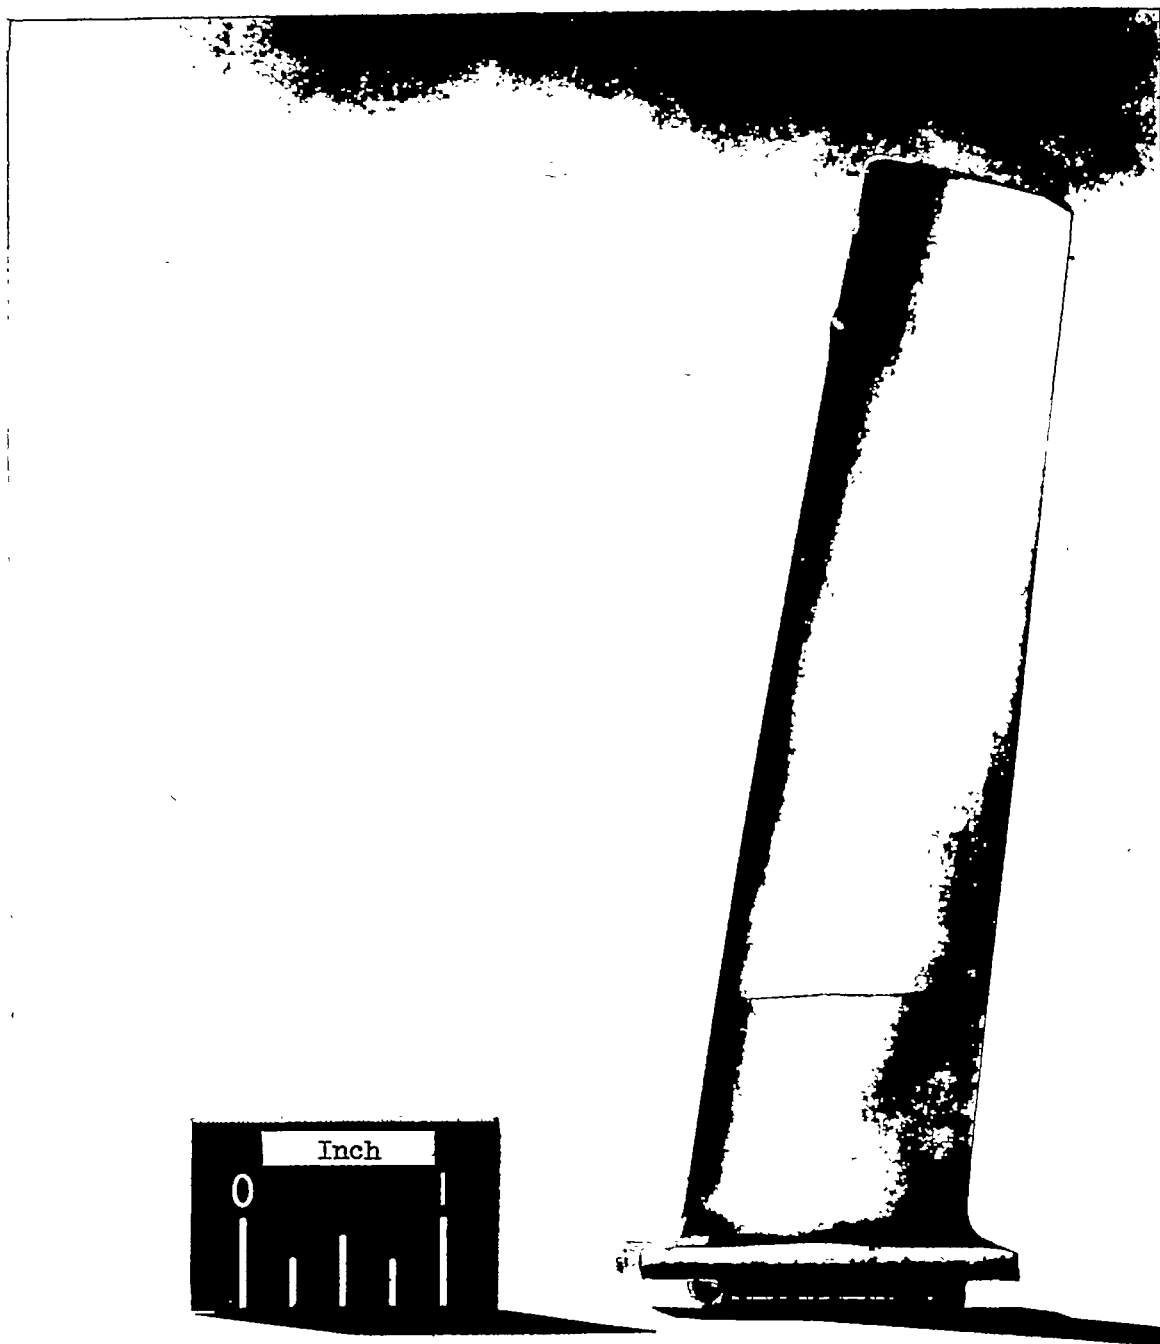
3356 A blade, which except for the tip region was initially undamaged, was fatigue tested to failure to determine the failure location (fig. 8). In this blade the crack started at the thickest part of the section on the suction surface. In other undamaged blades, failure started at the leading edge. The spanwise location of failure, regardless of where the failure started chordwise, was always about 30 percent of the span from the base of the airfoil. Both the analytical and measured stress distributions of figure 7 satisfactorily predict the critical section, the experimental curve giving the closest prediction.

Figure 8. - Blade with failure in normal location.

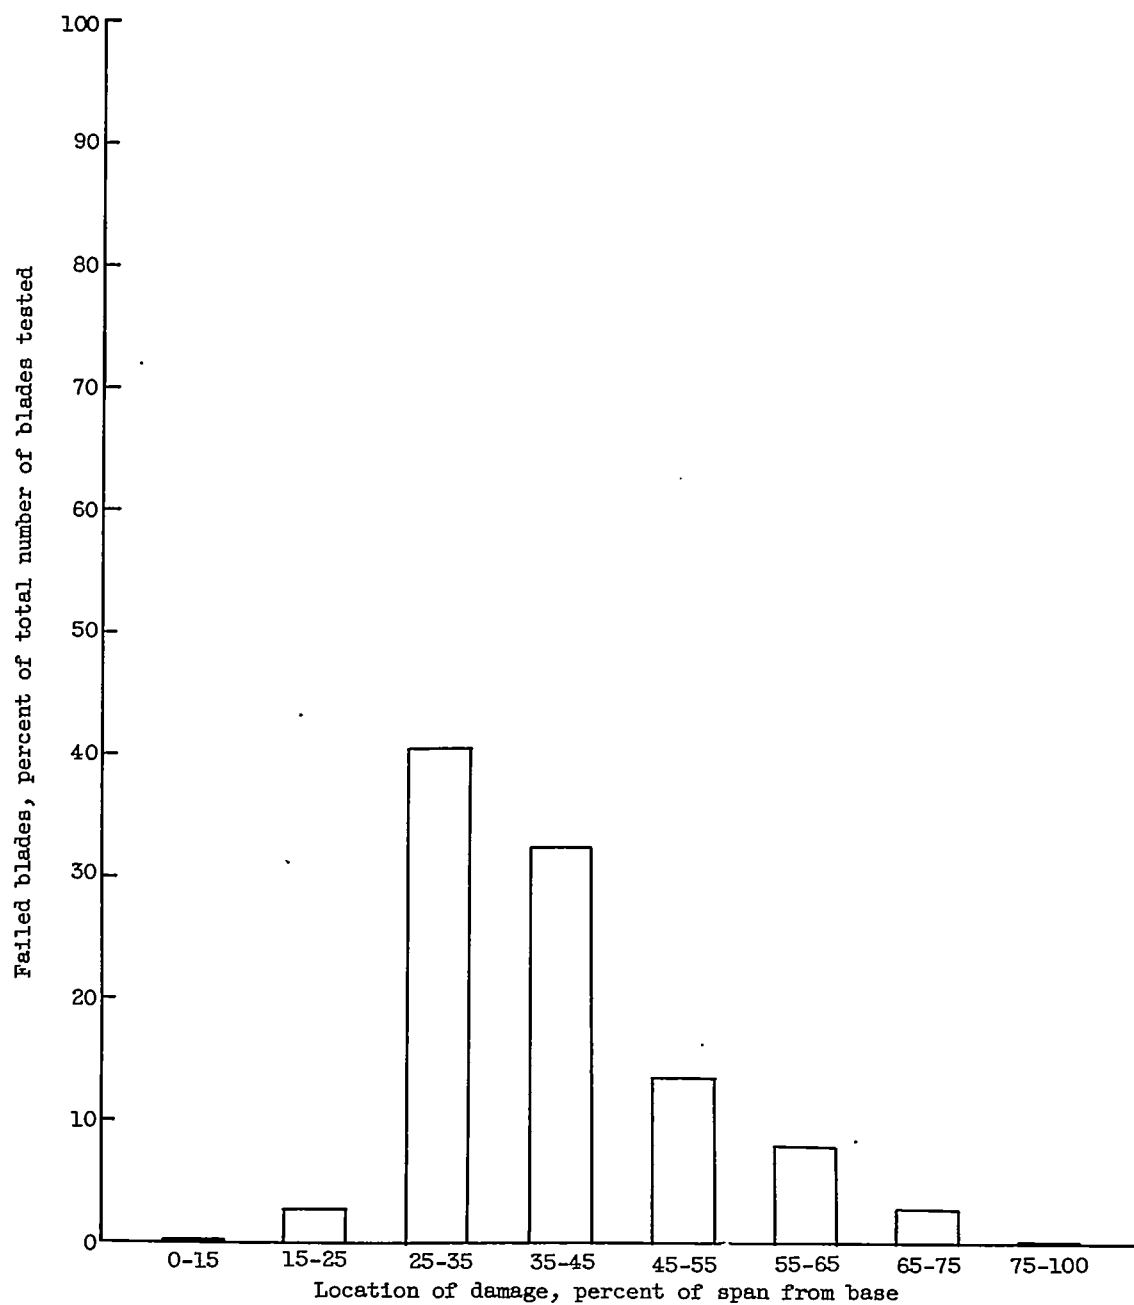
The results of the fatigue tests are shown in figure 9 in the form of a distribution of blade failures in various increments of span. The percent of blades that failed because of damage in each increment out of the total number of blades tested is shown by the lengths of the bars. The increment from 25 to 35 percent of the span from the base had the most sensitivity to damage. Over 40 percent of the total number of failures of damaged blades occurred in this small region. This was to be expected since the critical section falls within this span increment. The 35- to 45-percent-span region also showed a great sensitivity to damage.

Figure 9. - Percent of blades that failed out of total number of blades tested as function of failure location.

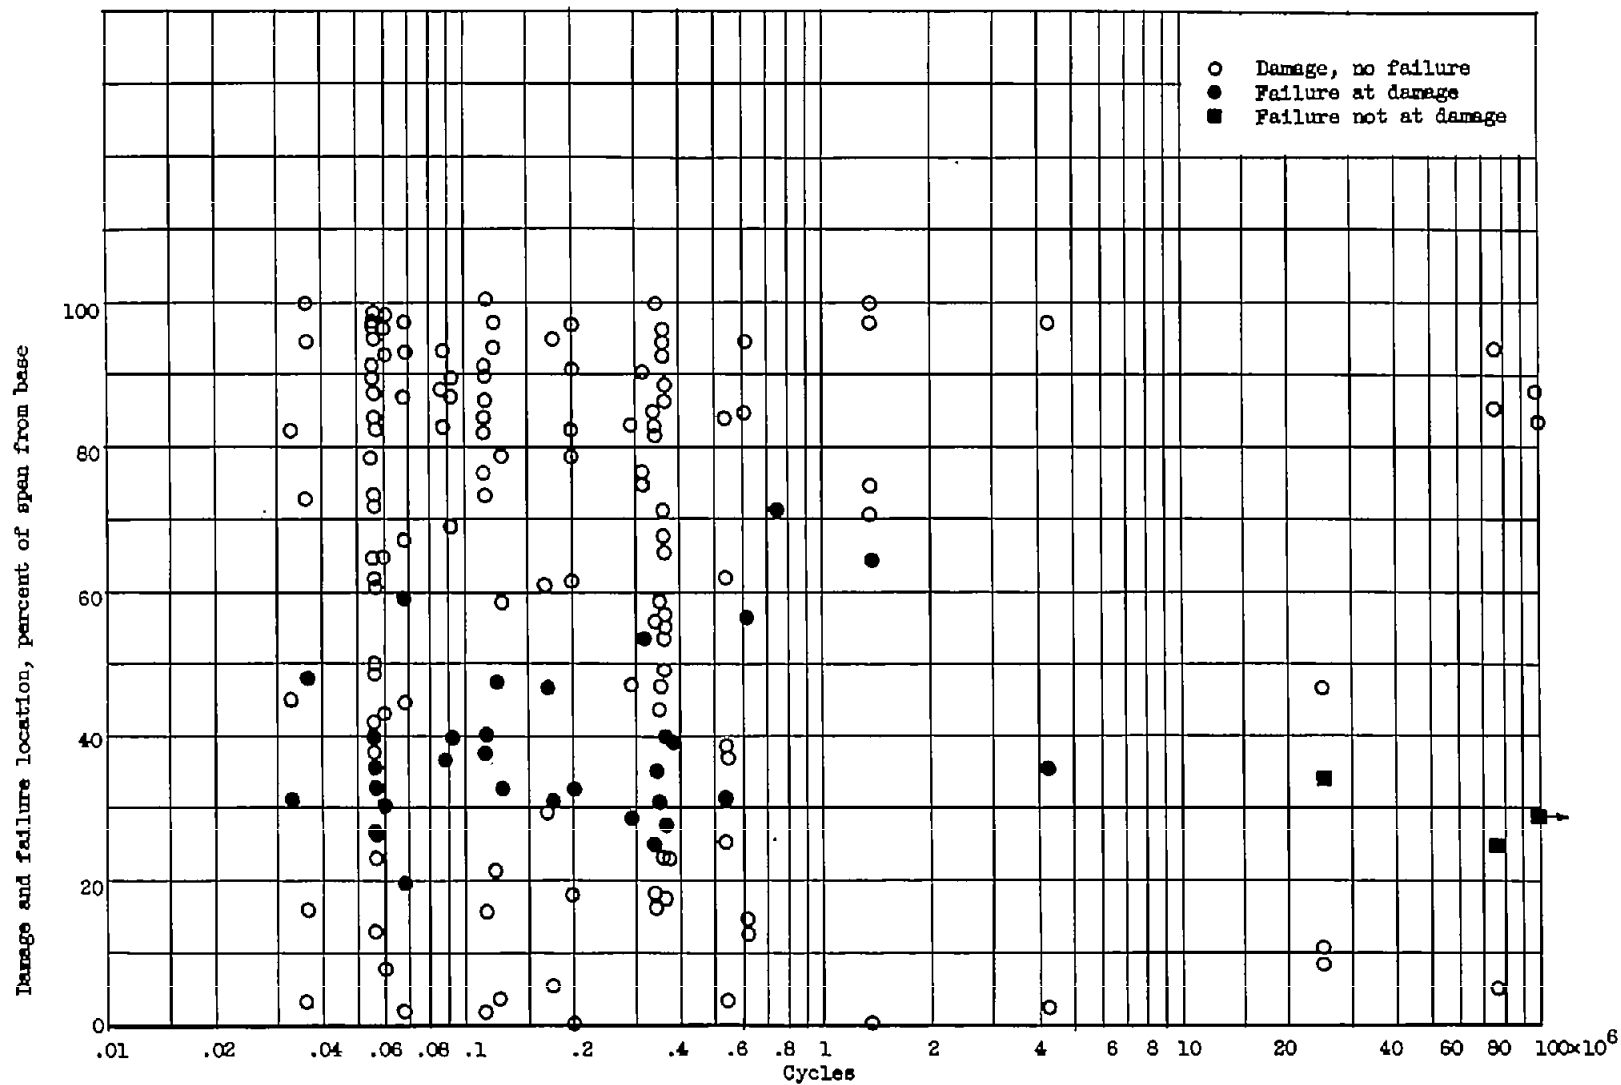
Neither the randomness nor the amount of blade damage is indicated by figure 9. Almost all of the blades suffered damage at locations other than where failure originated. There were also a few blades that failed at the 30-percent-span critical section at high numbers of cycles even though damage had been suffered at other locations. This can be seen in figure 10 where the solid circles denote damage defects where failure originated, the solid squares indicate where failure started when damage defects were not involved in the failure, and the open circles denote damage which did not cause failure.

From figure 10 it can be seen that nicks and dents were scattered over the whole span of the airfoil with the tip region having a greater concentration of damage. No failure occurred, however, because of defects located within 20 percent of the span from the base or within 25 percent of the span from the tip (in a total of almost half the airfoil span). Figure 10 also shows that there is a sharp reduction in the blade life whenever failure initiated at a damage defect.

Figure 10. - Fatigue testing results at stress level of $\pm 70,000$ psi.

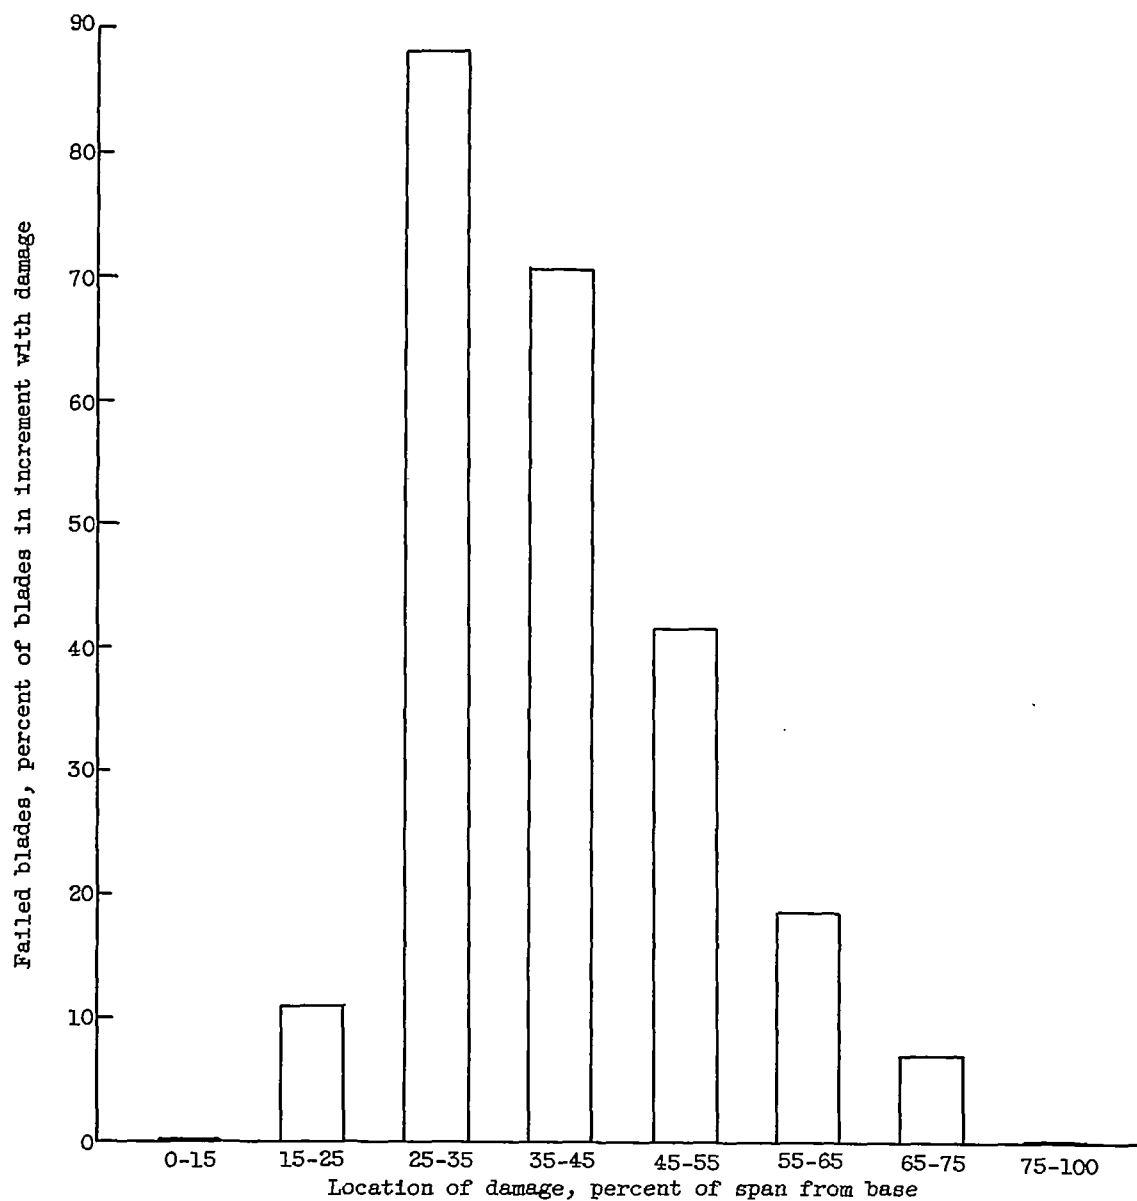
In figure 11 the airfoil span is divided into the same increments as in figure 9, but here the number of blades that failed in each increment is correlated with the number of blades that suffered damage in that increment rather than the total number of blades tested. Figure 11 is probably a fairer basis for evaluating the sensitivity of span location to damage than figure 9. From figure 11 it can be seen that in the 25- to 35-percent-span region nearly 90 percent of the blades damaged in that increment had failure originating at the damage. In the 35- to 45-percent-span region about 70 percent of the blades with damage in this region failed because of that damage.

Figure 11. - Percent of blades that failed out of number of blades in increment with damage as function of failure location.

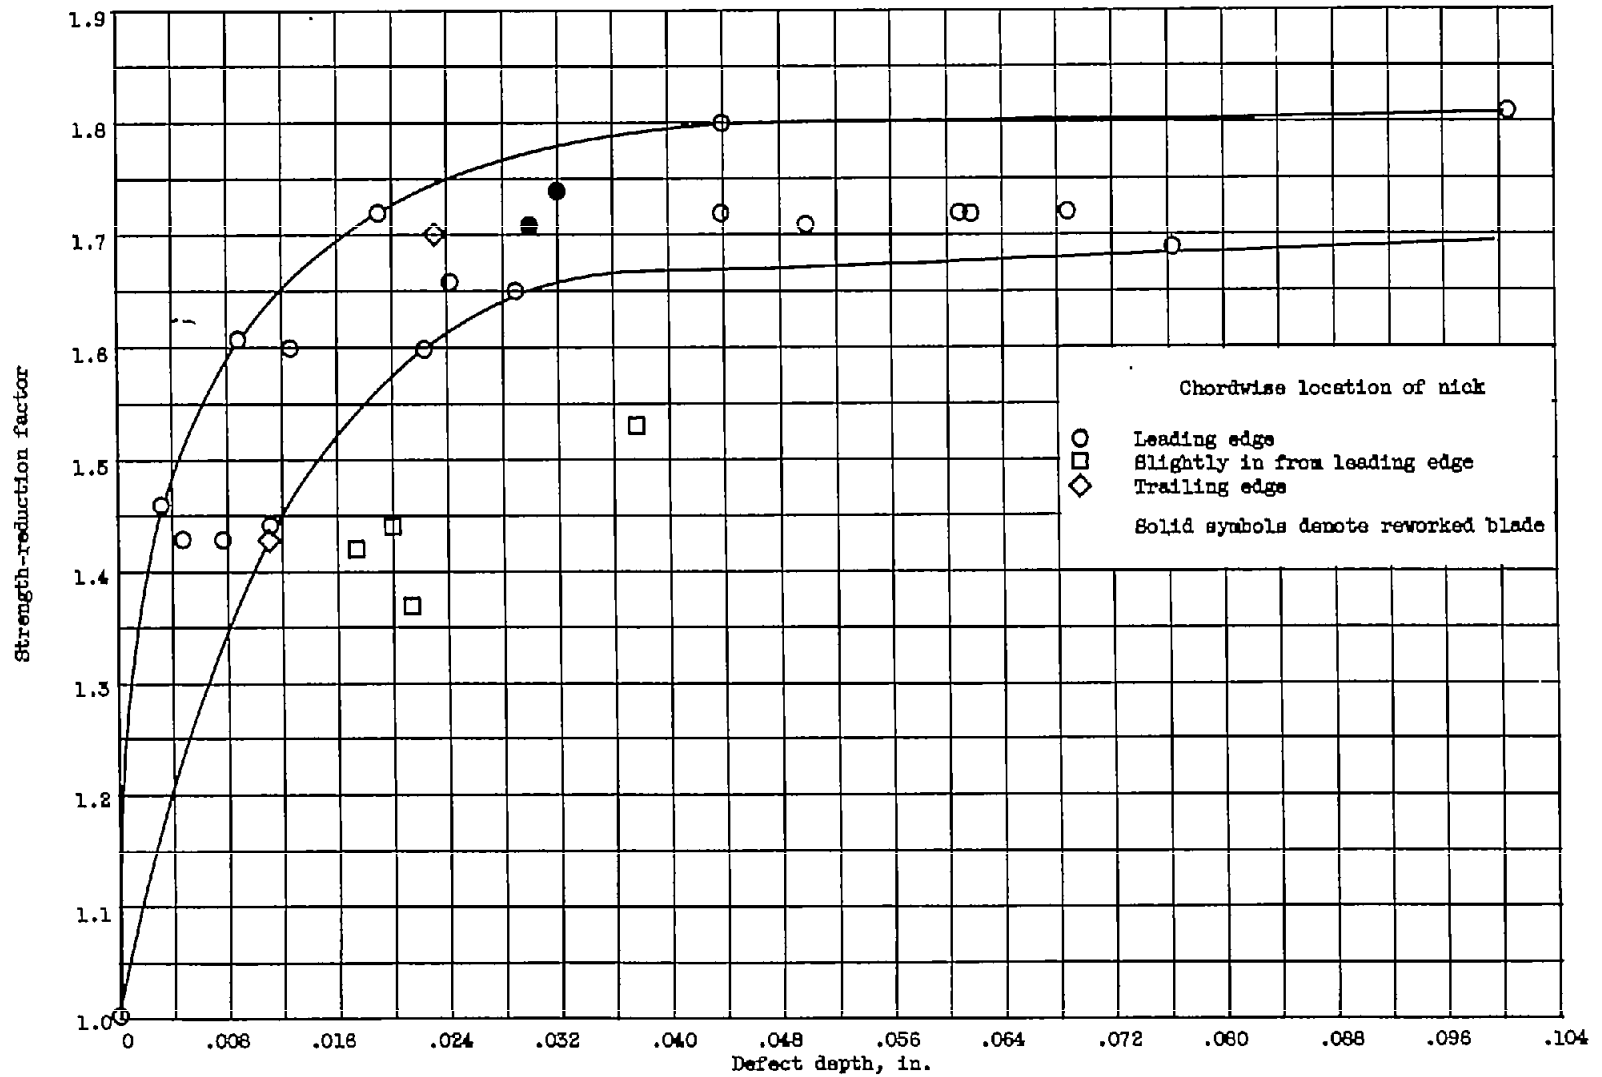
In figure 12(a) the results of the fatigue testing of blades which failed because of damage in the region between 20 and 45 percent of the span from the base are shown as a plot of the strength-reduction-factor parameter against the depth of the damage, which, owing to the jagged nature of some of the nicks, was the only pertinent dimension that could be determined. A band was drawn through the upper and lower limits of the data points for the failures due to edge nicks. In this region even the slightest nick sharply reduced the strength of the blade. Increasing the nick depth over $1/32$ inch did not further reduce the blade strength appreciably. There is no difference between the effects of leading-edge and trailing-edge nicks. If the nick is even slightly in from the edge, the strength-reduction factor drops sharply. In no case where a nick was more than $1/8$ inch from the edge did it result in premature blade failure. This must be qualified by the fact that no damage normally occurs on the suction surface of the blade. Conceivably, damage on the suction surface near the thickest part of the critical section could cause premature failure, since, for one of the undamaged blades (fig. 8), failure originated in that region. None of the blades investigated, however, showed impact damage on the suction surfaces due to foreign objects.

Additional conclusions can be drawn from the data presented in figure 12. First, very small nicks in the leading or trailing edge are extremely detrimental to blade life when located near the maximum-vibratory-stress region. For example, a 0.010-inch-deep nick which is relatively difficult to detect upon inspection without complete disassembly of the engine had an average strength-reduction factor of about 1.5 (fig. 12(a)). A blade normally vibrating at $\pm 70,000$ psi would sustain about 10^8 cycles before failure. With a 0.010-inch-deep nick, a blade vibrating at the same nominal stress according to figure 6 would sustain only 2.3×10^5 cycles before failure ($70,000 \times 1.5 = 105,000$ psi effective stress). This constitutes a reduction in blade life of $1000/2.3$, or 435 to 1. When a blade with a 0.010-inch-deep nick vibrates at $\pm 47,000$ psi ($70,000/1.5$), it is possible to have a failure in 10^8 cycles while the undamaged blade can vibrate indefinitely near this stress level. The time to failure may be relatively short, because the average inlet-stage blades undergo 10^6 cycles per hour of vibration, and exit stages undergo as many as 5×10^6 cycles per hour.

(a) Nicks in 20- to 45-percent-span region.

Figure 12. - Effect of defect depth and location on strength reduction.

Efforts to improve the strength of blades with sizeable nicks, while keeping the reworked or filed-out area to a minimum so as not to affect the blade aerodynamically, were unsuccessful. Nicks were filed in two undamaged blades at the critical section on the leading edge to a depth of about $1/32$ inch. These nicks were then dressed out with files and emery cloth until no sharp edges were left, only a smoothly faired indentation on the leading edge. The results of fatigue testing these two blades are shown in figure 12(a). There is no discernable improvement in strength due to the reworking of these nicks.

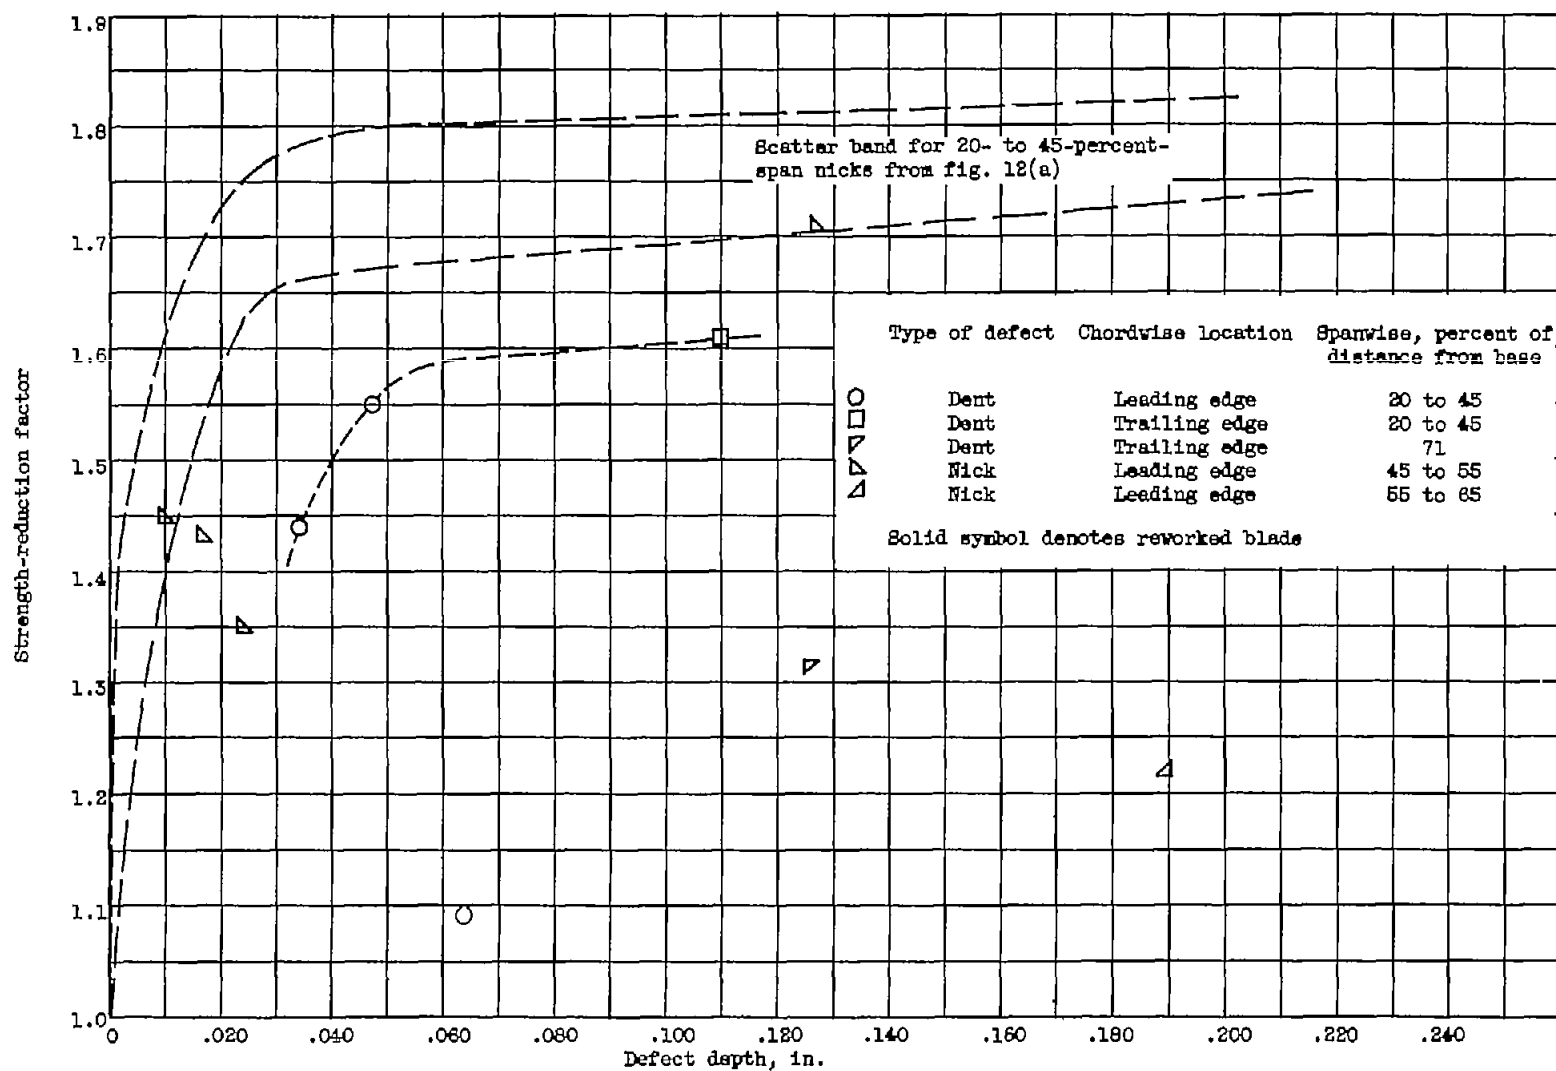
In figure 12(b) the effects of nicks, outside the 45-percent-span region, and of dents are shown. The strength-reduction factors for edge nicks above the 45-percent-span region either fell below or at the lower

limit of the scatter band replotted from figure 12(a). Dents, even those in the 20- to 45-percent-span region are less serious than nicks of comparable depth.

(b) Nicks outside 20- to 45-percent-span region and dents.

Figure 12. - Concluded. Effect of defect depth and location on strength reduction.

To find what effects, if any, reworking has in improving the strength of damaged blades, a number of fatigue tests were conducted with the nicks and dents reworked. One blade with a dent at 36 percent span on the leading edge, which might have been expected to introduce a strength-reduction factor of 1.6 from figure 12(b), was reworked by hammering the dent until the leading edge was straight. The resulting strength-reduction factor was only 1.09. A second blade with a reworked dent at the critical section on the leading edge was run at the endurance limit of the material for 10^8 cycles without failing.
